Diagnostics of insulators Failures on Overhead Lines

P. Kučík, SlovCert, s.r.o., Bratislava, Slovak Republik
T. Šmida, IBOK, a.s., Bratislava, Slovak Republik**

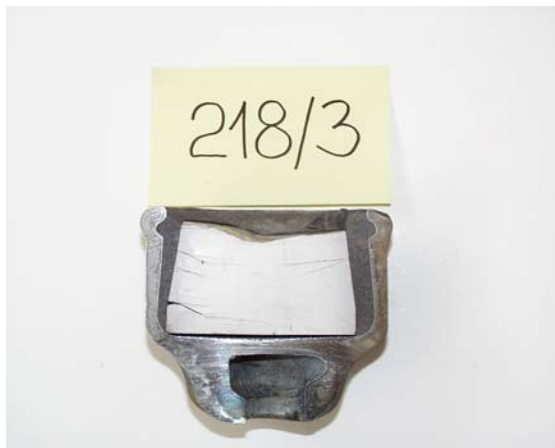
Figure 5. Transverse cuts and network of thin cracks in the head of the broken insulator

breakdowns it was concluded that a stable crack growth off the perimeter precedes the final fracture taking part at the bulk of the insulator. The main breakdowns were result in destruction of the head of the insulator into slices with flat peripheral region and inded central part (Fig.5 and 6).

The transverse cuts of insulators revealed a dence network of thin cracks, combined with less frequent and thicker defects in the peripheral region of the insulator.

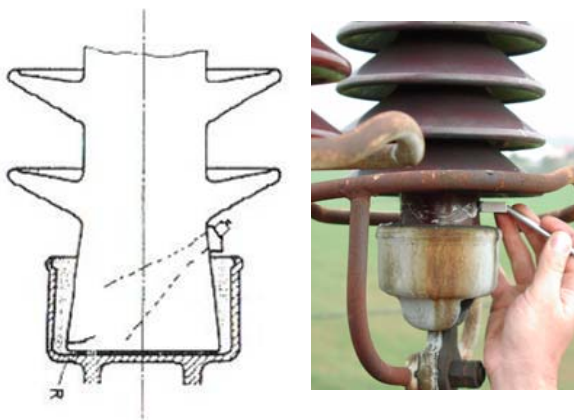
Figure 8. Schema of the using ultrasonic probe to detect transversal crack at head of the insulator and practical testing by angle beam probe

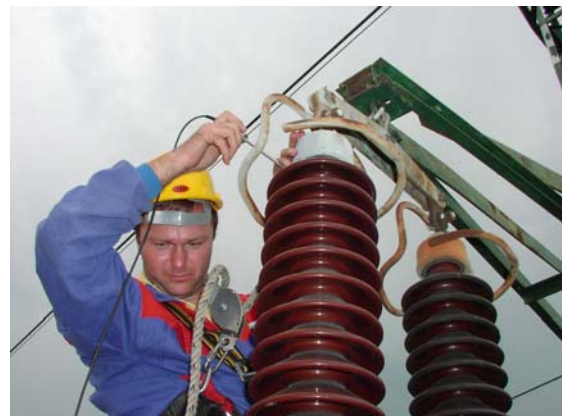
Figure 9. Ultrasonic testing on the hanging ceramic insulators of 440 kV transmission lines
